Revista Brasileira de Geomorfologia

Technical report

Cabo Branco Cliff – João Pessoa, PB: Geomorphological characterization and associated erosional processes

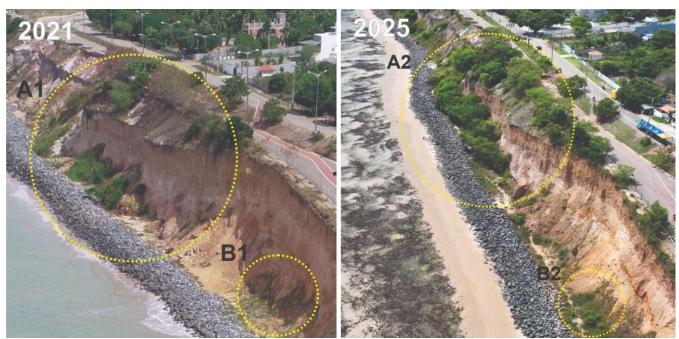
Figure 05. Comparative analysis (2021–2025) of vegetation on talus deposits at the base of the Cabo Branco cliff – PB.

With the cliff base now protected by an artificial erosion-control structure, the ravinement process, already initiated, has become concentrated in the upper portion of the escarpment, where the presence of unconsolidated deposits is evident. Such deposits are common across several cliffs in Northeastern Brazil (e.g., Redonda–CE, Beberibe–CE, Pipa–RN, Barra de Tabatinga–RN). At the base, the talus deposits, now sheltered by the structure, have begun to be colonized by arboreal vegetation (Figure 05 – A2).
