## Revista Brasileira de Geomorfologia

v. 27, nº 2 (2026)

# Soil Loss Estimation in Gullies of the Colônia Antônio Aleixo Basin, Manaus, Amazonas, Brazil

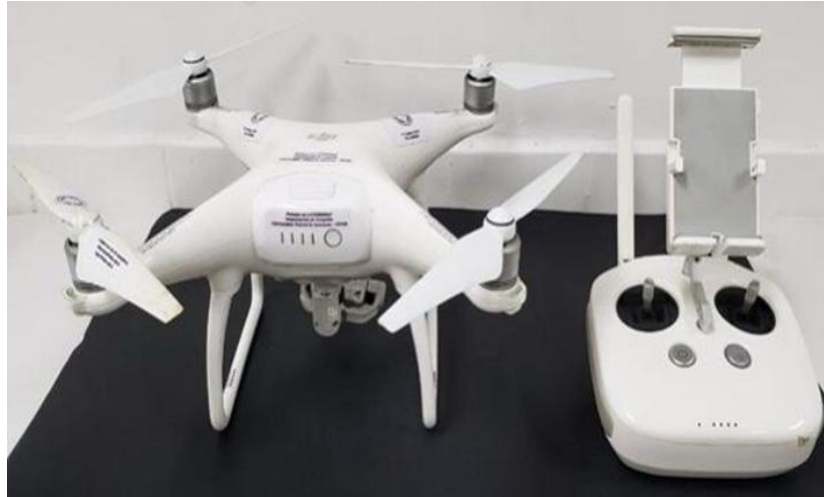
**Figure 2.** Unmanned Aerial Vehicle (UAV), DJI Phantom 4 model. Source: Prepared by the authors (2026). Photograph taken on February 5, 2024.

Gully monitoring was conducted using a Phantom 4 Unmanned Aerial Vehicle (UAV) during survey flights performed on September 10, 2017, and January 7, 2020. Flight planning and execution were carried out using Pix4D software for the Phantom 4 platform (Figure 2).

The UAV was configured with 75% lateral and longitudinal overlap and equipped with a 4K-resolution camera tilted at 70°. Flight missions were planned in Grid Mission mode at an altitude of 60 m above ground level. This configuration provided a spatial resolution of 10 cm pixel<sup>-1</sup>, with a planned Ground Sample Distance (GSD) of 2.79 cm pixel<sup>-1</sup>, ensuring adequate coverage and high image quality.

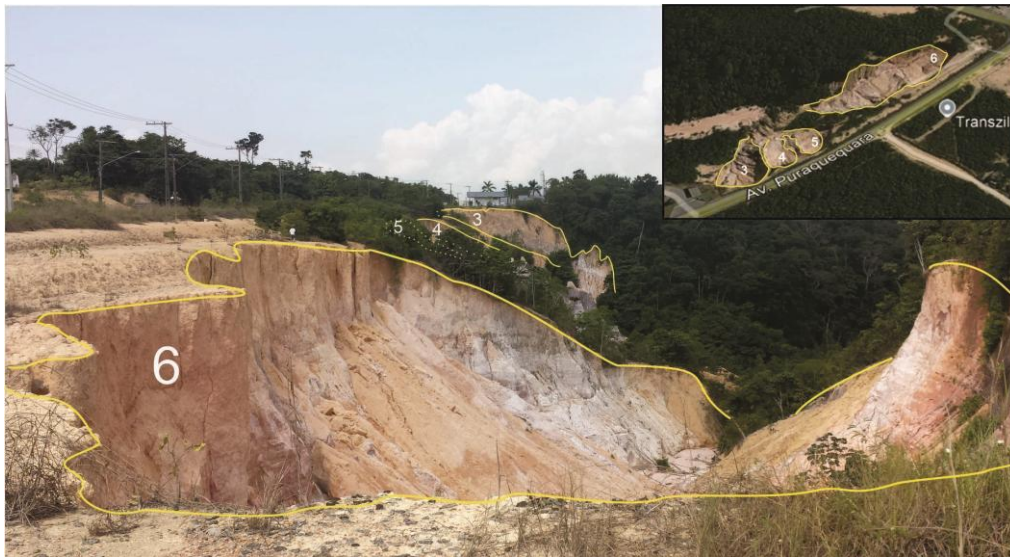
**Figure 10.** Evolution of gullies in the Distrito Industrial II neighborhood, Colônia Antônio Aleixo watershed. Sources: Authors (2013) and © Google Earth (2005). Prepared by the authors (2026).

Regarding Gullies 03 and 04, this hillslope initially exhibited a system composed of four gullies (Figure 10), which subsequently underwent evolutionary and capture processes, resulting in the elimination of one feature due to coalescence between Gullies 04 and 05.

Incisions 04 and 05 (Figure 10), developed on the same hillslope and already reaching the summit, were classified as integrated gullies and exhibited progressive widening and coalescence resulting from the collapse of the wall separating them, leading to the formation of a single gully (Figure 15), currently designated as Incision 04. A similar dynamic is likely to occur between Incisions 03 and 04, considering that both exhibited width expansion and increasingly rounded headcuts, progressively approaching a rectangular morphology.

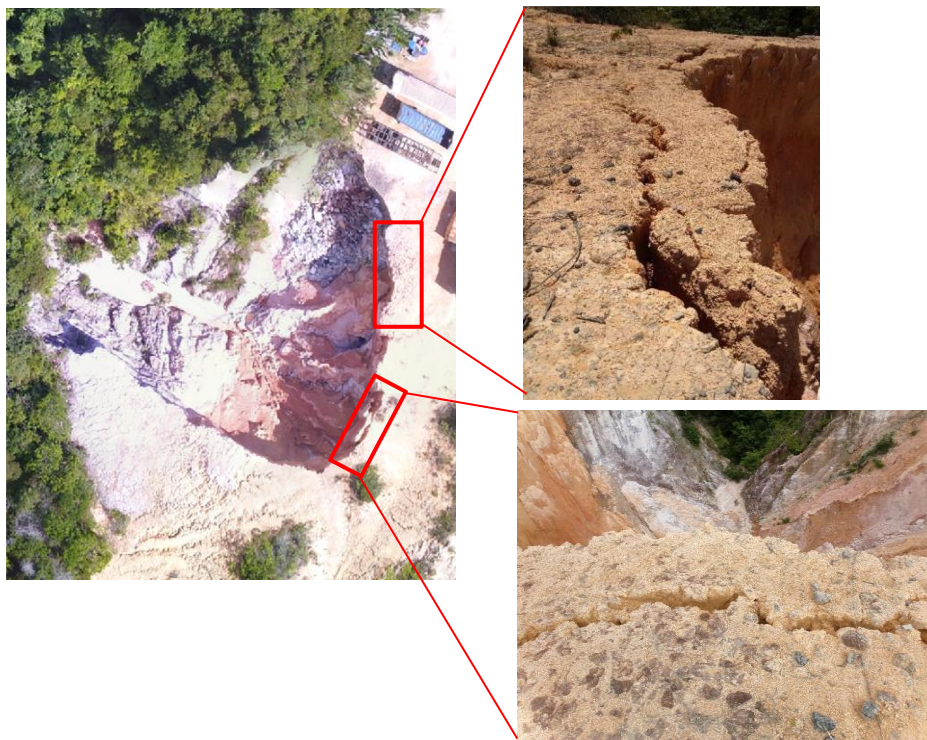
**Figure 14.** Rills along the margin of Gully 01, Distrito Industrial II neighborhood. Source and prepared by the authors (2026).

Tension cracks were observed along the margins and headcut of Gully 01, indicating terrain instability and lateral wall retreat through collapse processes (Figure 14). These features demonstrate that the gully remains active and indicate the occurrence of generalized mass movements contributing to its ongoing evolution. The same growth pattern was identified in the other monitored incisions, following dynamics similar to those described in previous studies (Augustin and Aranha, 2006; Silva et al., 2017; Rocha et al., 2018; Pinto and Araújo, 2020; Xavier et al., 2023).
