## Revista Brasileira de Geomorfologia

v. 27, n° 2 (2026)

# Retrogressive Breach Failure in a Tropical Sandy Spit: A Case Study in Puntarenitas, Costa Rica

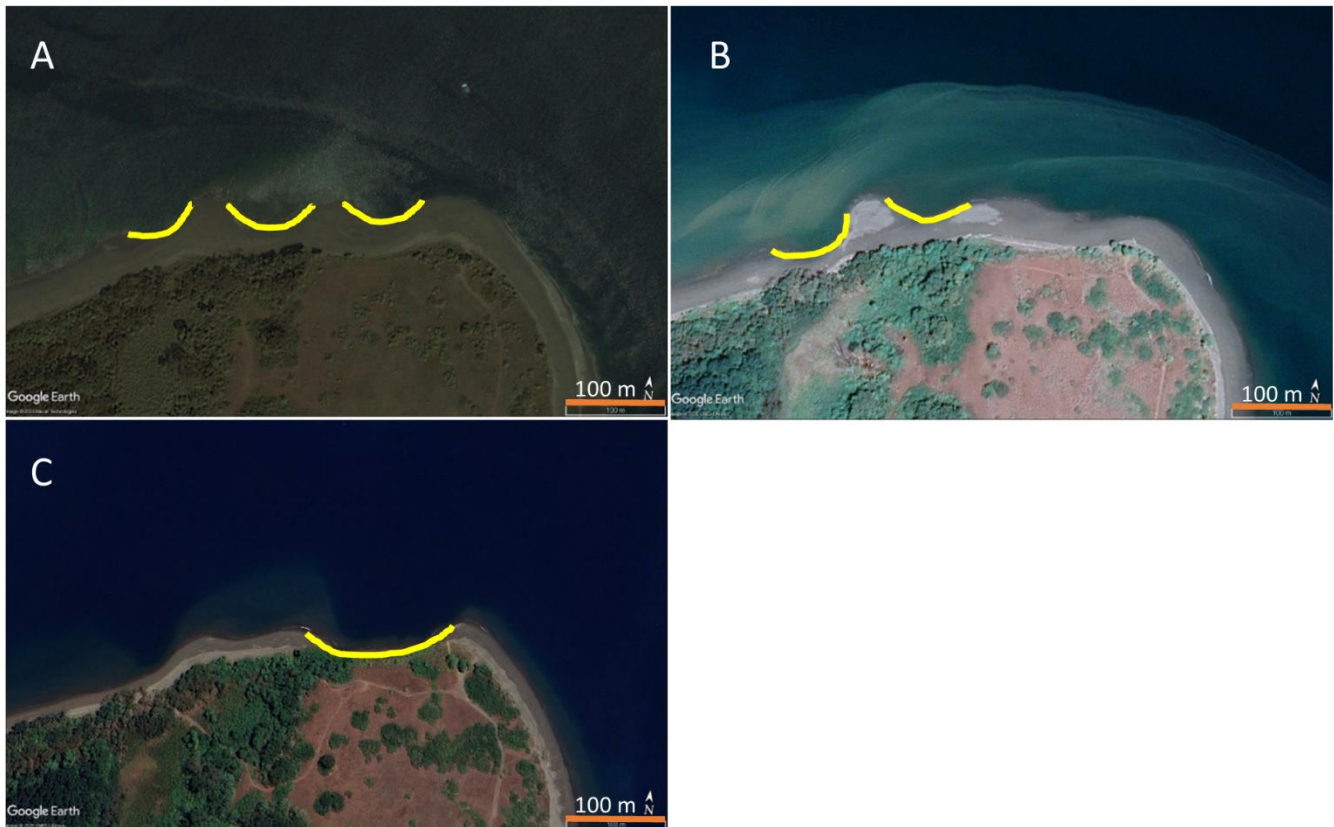
**Figure 4.** Remaining evidence of three events mapped on Google Earth imagery. Yellow lines mark the evidence of scarp crowns that are visible in the images. A) The February 9<sup>th</sup>, 2008 event, in which three scarp crowns are visible: the one on the right is located at the same site as the February 2024 event, although it is smaller, while the other two on the left are in similar positions to the scarps observed in the 2017 event. B) Marks the evidence of the January 27<sup>th</sup>, 2017 event, showing two crowns, one to the left and the other toward the center, although it is unclear whether one occurred at the same location as the February 2024 event. C) The February 8<sup>th</sup>, 2024 event, captured in an image taken on March 7<sup>th</sup>, 2024. Source: Google Earth (2008, 2017, 2024).

As reported by local inhabitants, evidence of similar past events can be identified, particularly those occurring in February 2008 (Figure 4 A) and January 2017 (Figure 4 B). Notably, one of the three scarp crowns identified from the 2008 event coincides with the location where the 2024 event occurred (Figure 4 C).

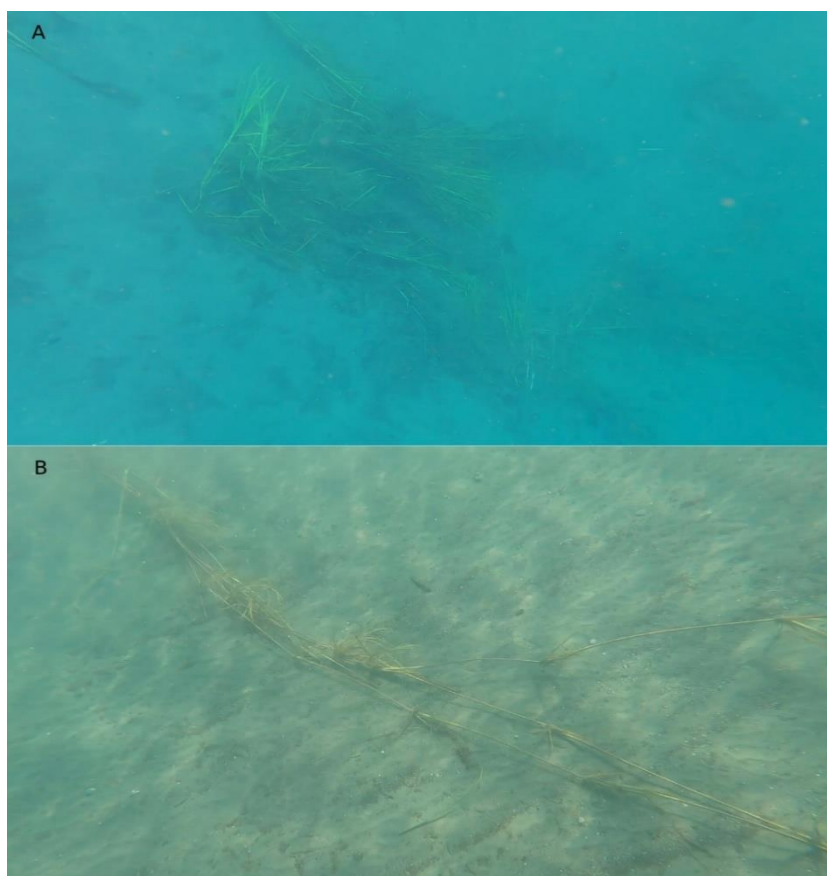
**Figure 6.** Qualitative demonstration of grass debris (A and B) transported downslope from higher grounds and deposited at the base of the slide mass during the February 8<sup>th</sup>, 2024 event.

The average temperature and salinity values at Puntarenitas Beach were 31.7 °C and 31.3 PSU, respectively. At Puerto Jiménez Beach, the average values were 32.0 °C and 31.1 PSU for temperature and salinity, respectively. These values are higher than those previously reported by Rincón and Ballesterio (2015), with an average temperature of 30.5°C and 30.5 for salinity (PSU). Profiles were taken in a transect at the affected area and no significant differences were being noticed on the three measured variables. No colder or less salty water masses were detected during the measurements (Figure 5). Even further, no significant low salinity values (< 30 PSU) were detected in our measurements and those made by Ricón and Ballesterio (2015) in the affected area, which would point to freshwater infiltration. Density did not vary significantly during sampling of the seven profiles along the shoreline. Nonetheless, the measurements were taken 4 days after the event. During the immersion conducted, it was possible to observe that the two escarpments visible on land continued underwater in a step-like shape with remnants of terrestrial grasses observed (Figure 6).

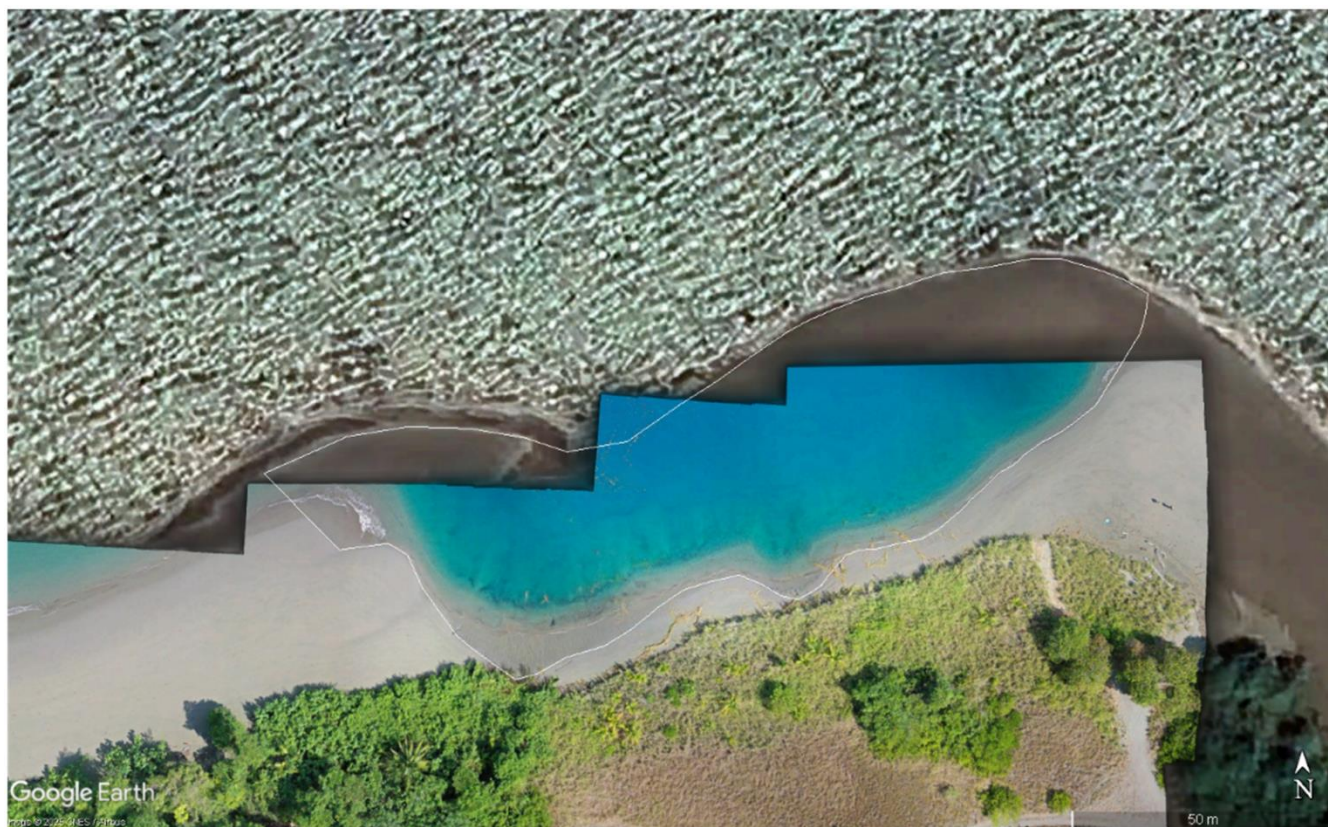
**Figure 8.** Estimated boundary of the beach area lost (indicated by the white line on the image). Bottom: Google Earth satellite imagery (July 2, 2023). Top: UAV-derived orthophoto mosaic, acquired and processed on February 13<sup>th</sup>, 2024.

An affected area of 410 m<sup>2</sup> was estimated using the orthophoto mosaic constructed from the drone flights and the coastal limit at the instantaneous waterline on the July 2<sup>nd</sup>, 2023 image (Figure 8). Within the affected area, a main escarpment (i.e., crown) and three secondary escarpments were recognized. Lengths of 167.7 m were recorded for the main crown and 64.4 m, 20.1 m, and 29.1 m for the secondary escarpments, respectively, from west to east (Figure 9).

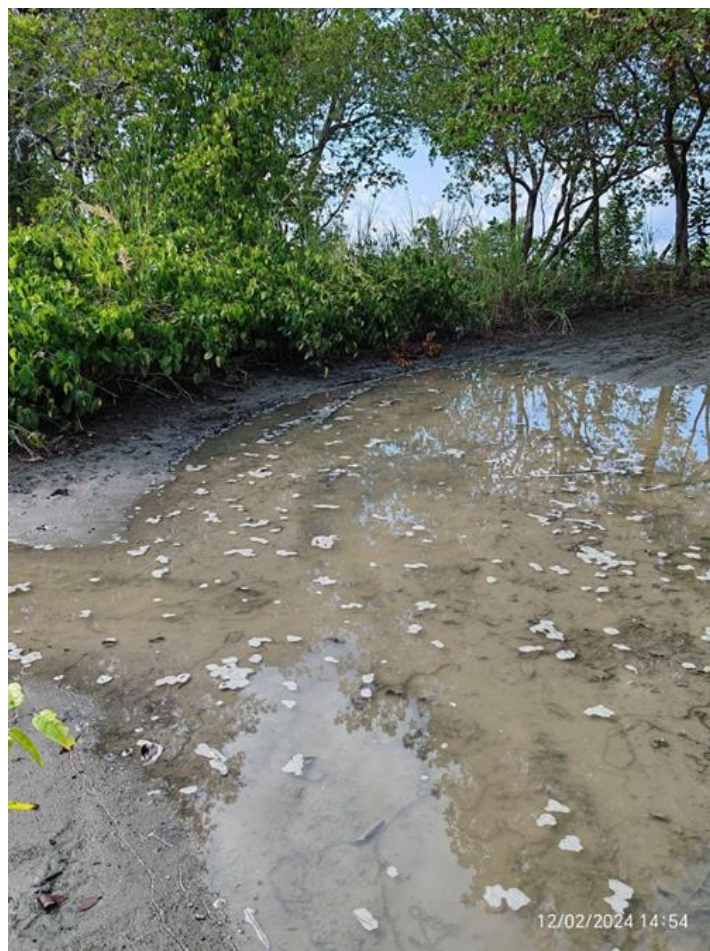
**Figure 14.** Groundwater emerged just a few meters right beside the affected area. Source: Barrantes et al. (2024).

On the other hand, a wetland located approximately 300 m away from the shoreline suggests the presence of a shallow water table (1 to 2 m deep) at the study site (Figure 14) and found at approximately 4 m of depth at the sandy spit, located 400 m to the south (Barrantes et al., 2024).
